# RL1200 – v1 fixes

The first version (v1) of this board has some issues that required a bill of materials change and corrections to the silkscreen markings:

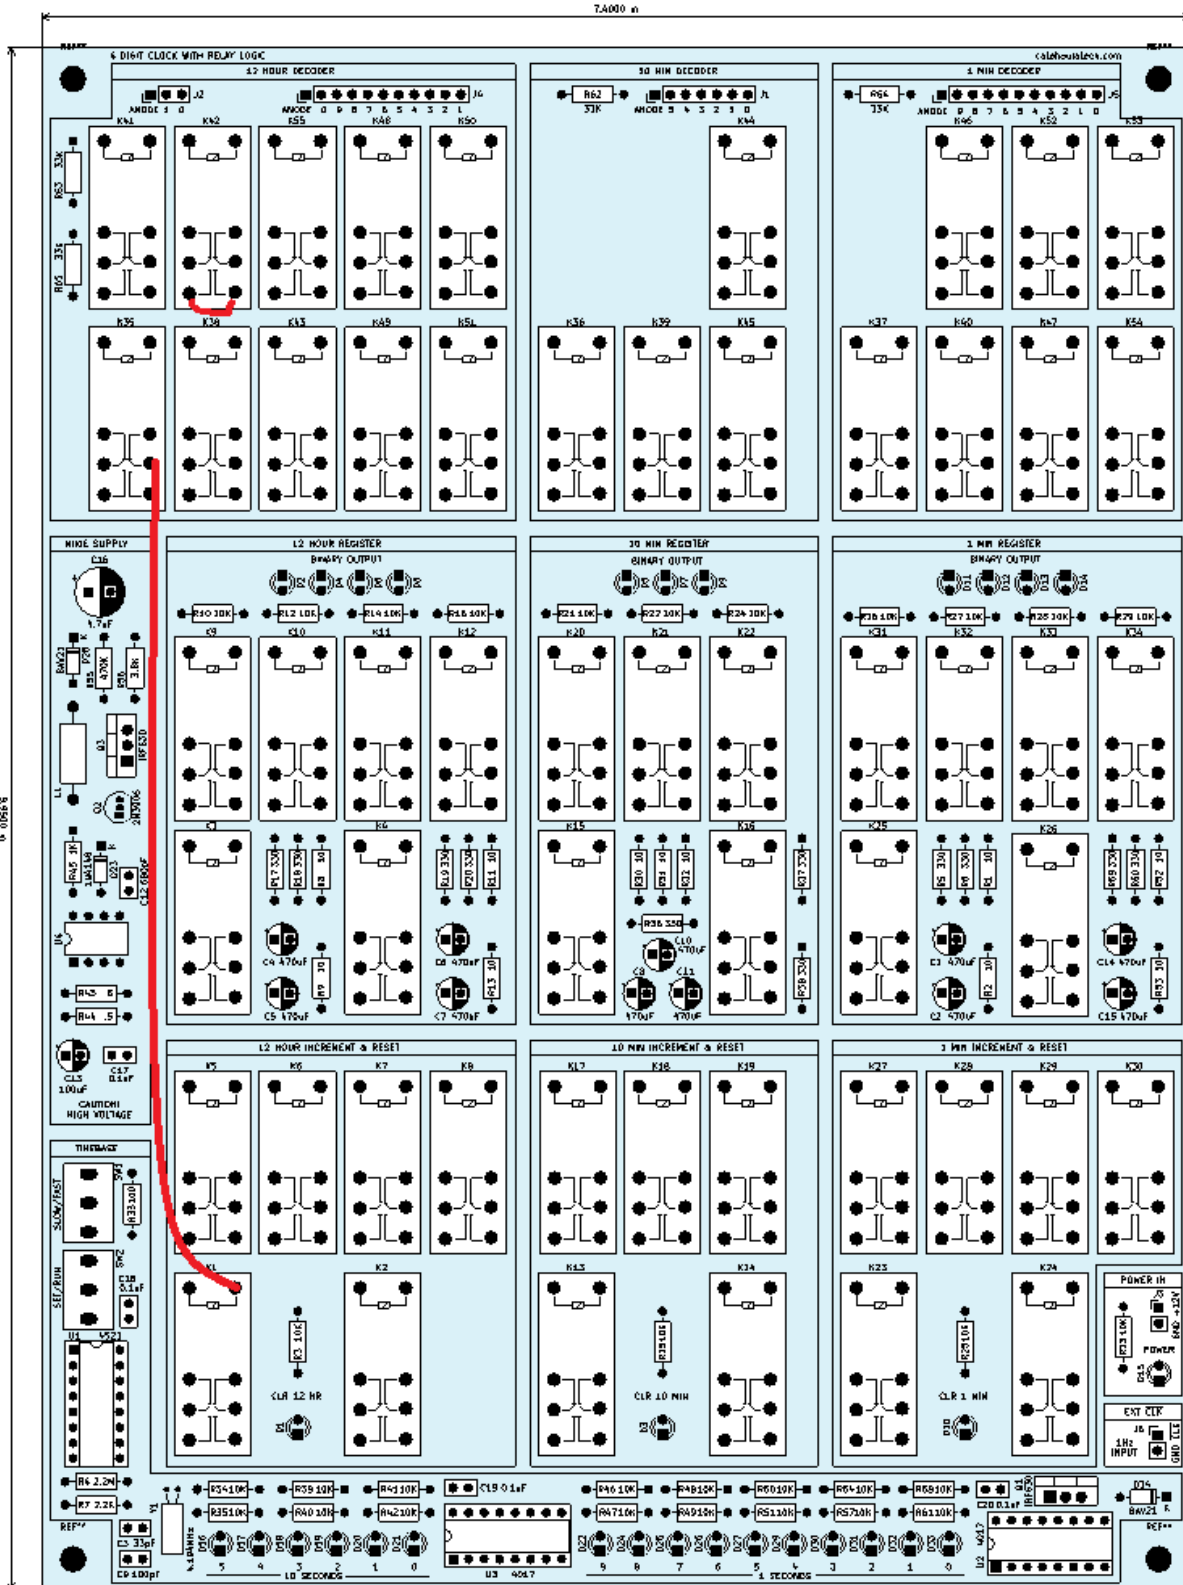
Routing errors on the board require a few manual modifications with wires:

1. Connect K42 pin 4 and 5 together with a wire
2. Connect K35 pin 6 to K1 pin 8 with a wire
3. Cut 2 traces leading to pin 13 of U1 (CD4521) and rewire to pin 14 so clock runs off 1Hz.
  - a. Incorrect routing was to 2Hz output so the clock would run 2x too fast.
